# Manhole Inspection Summary

Manhole # S67Y\_\_003MH

Insp Date: **5/5/08 2:22 PM**

**Location** Address: **6200 Beckley St.**

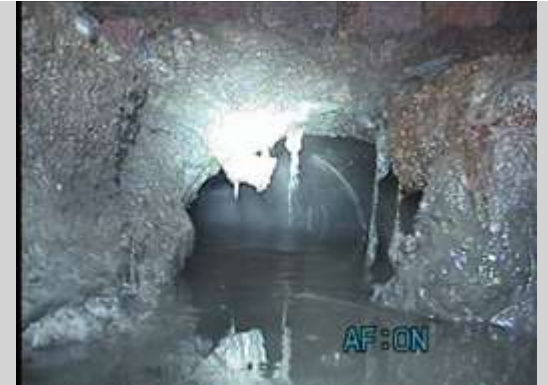
12 O'Clock Outflow

12 in. Circular Gravity Sewer  
Pipe Out @ 12 O'Clock

Pipe Height: **14.4** (in.) Rod and Bar (Angled)  
Pipe Material: **Clay** ☐ Pipe Lined  
Invert Depth: **13.17** (ft.) Flow Characteristics: **Slow**  
Deposits: ☐ None ☐ Mud ☒ **Sludge** ☐ Debris ☐ Grease  
Silt Depth: **1.5** (in.) Deposits Extent: **Light**  
Infiltration: **None** Pipe Seal Cond: **Sound**

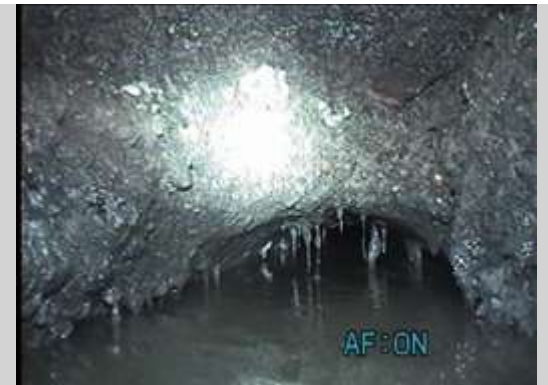
5 O'Clock Inflow

12 in. Circular Gravity Sewer  
Pipe In @ 5 O'Clock

Pipe Height: **14.4** (in.) Rod and Bar (Angled)  
Pipe Material: **Clay** ☐ Pipe Lined  
Invert Depth: **13.08** (ft.) Flow Characteristics: **Slow**  
Deposits: ☐ None ☐ Mud ☒ **Sludge** ☐ Debris ☐ Grease  
Silt Depth: **1.5** (in.) Deposits Extent: **Light**  
Infiltration: **None** Pipe Seal Cond: **Sound**

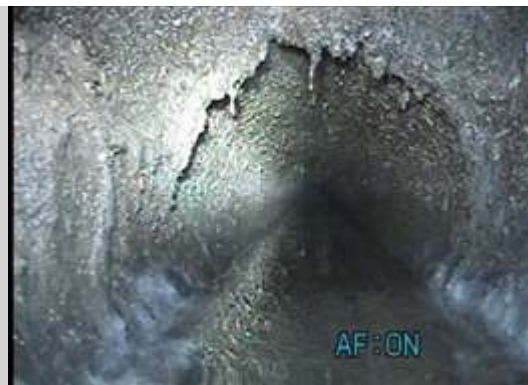
7 O'Clock Inflow

15 in. Circular Gravity Sewer  
Pipe In @ 7 O'Clock

Deposits: ☐ None ☐ Mud ☒ **Sludge** ☐ Debris ☐ Grease

Silt Depth: **0.25** (in.) Deposits Extent: **Light**
